**United States Environmental Protection Agency
Region 5
77 West Jackson Boulevard
Chicago, Illinois 60604**

Date: September 16, 2014
Site Visit: Rasmussen's Dump, Spicer Road, Brighton (Green Oak Township),
Michigan 48116
From: Howard Caine, RPM *mark*
To: File

Introduction and Purpose

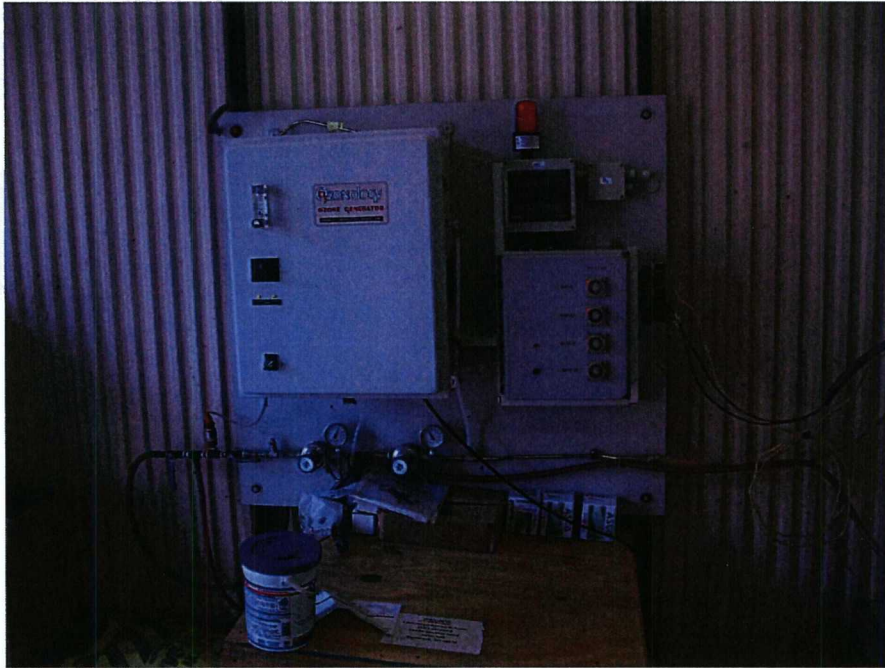
Photo 1: Ozone Generator

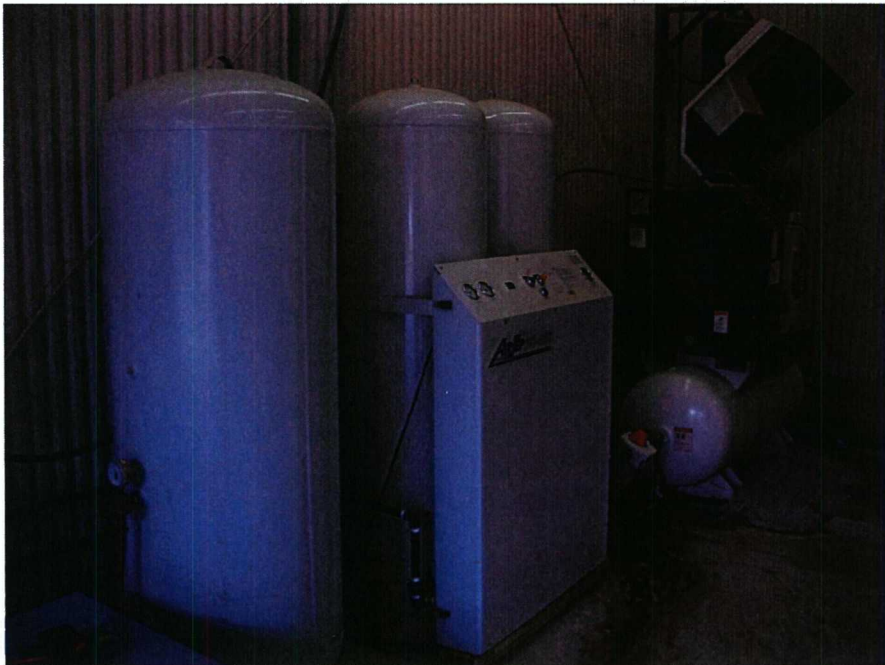
Photo 2: Ozone Concentrator

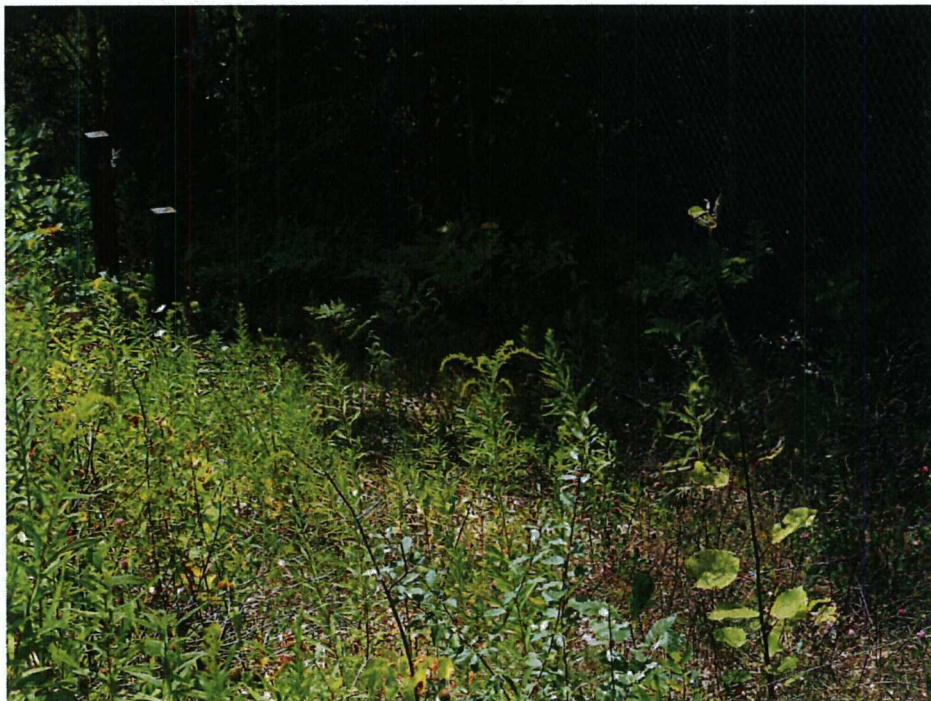
The monitoring wells that were observed were properly locked and secured, are routinely sampled and were in good condition.

Photo 3: Groundwater Monitoring Well Nest CRA-RA-26

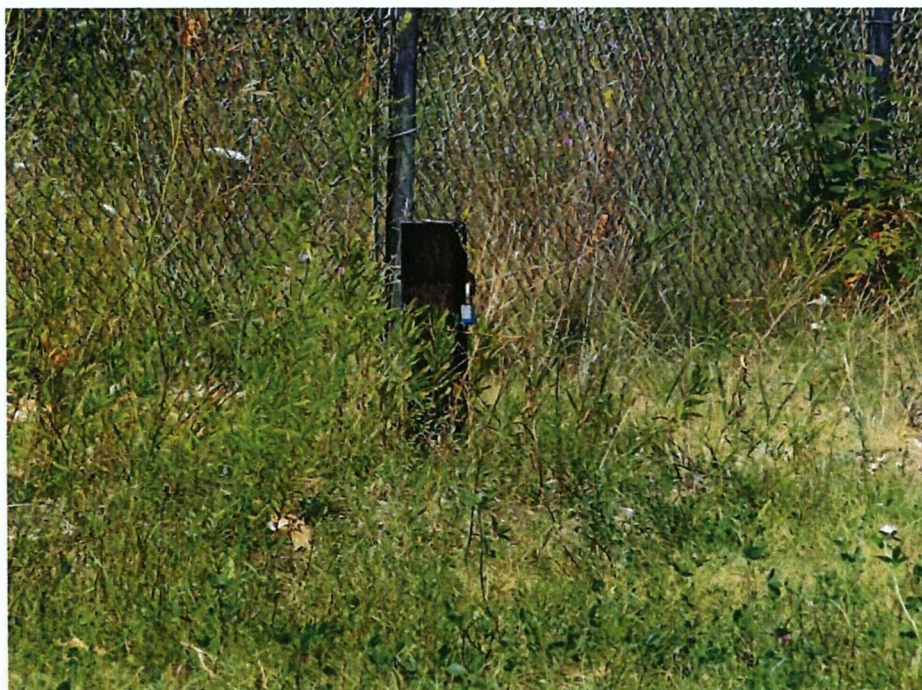
Photo 4: Groundwater Monitoring Well CRA-RA-27

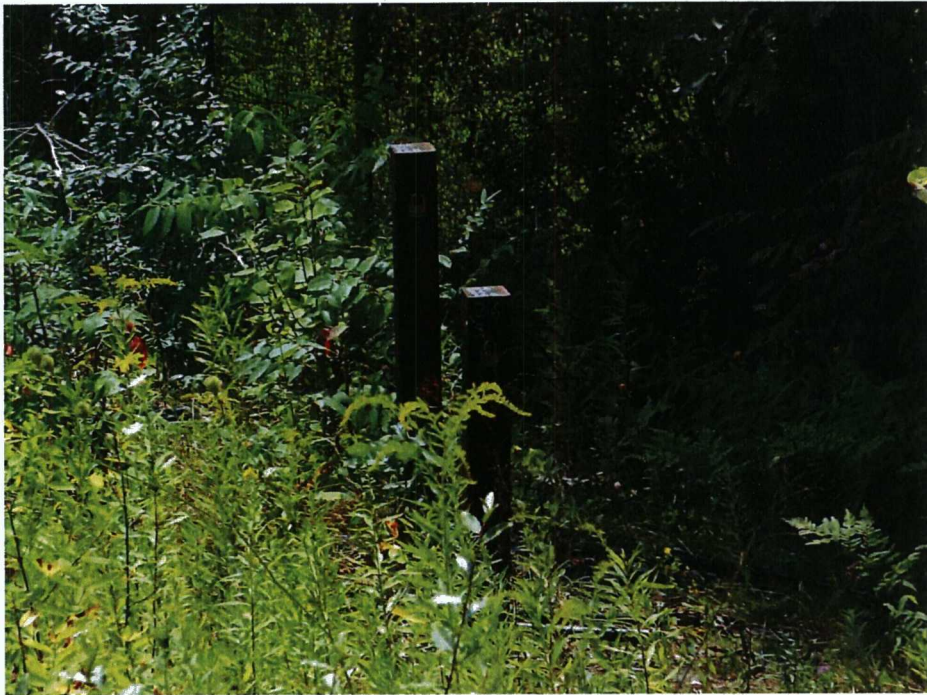
Photo 5: Groundwater Monitoring Well Nest CRA-RA-26

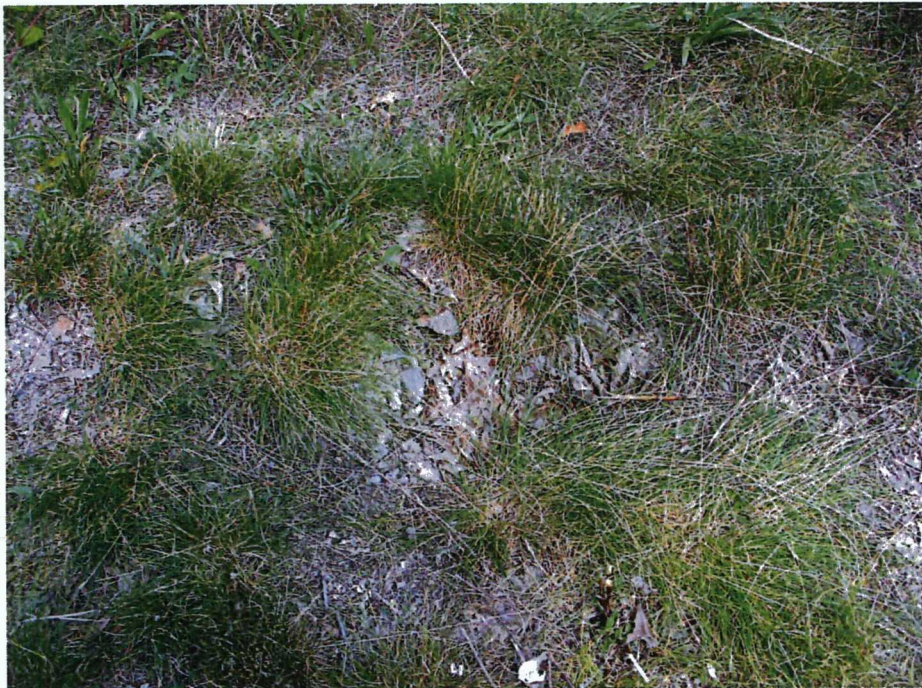
The roads appeared to be maintained. The Site appeared to be in adequate shape. One sparge point had settled on the south side of the landfill and needed filling in.

Photo 6: Collapsed Sparge Point to be filled

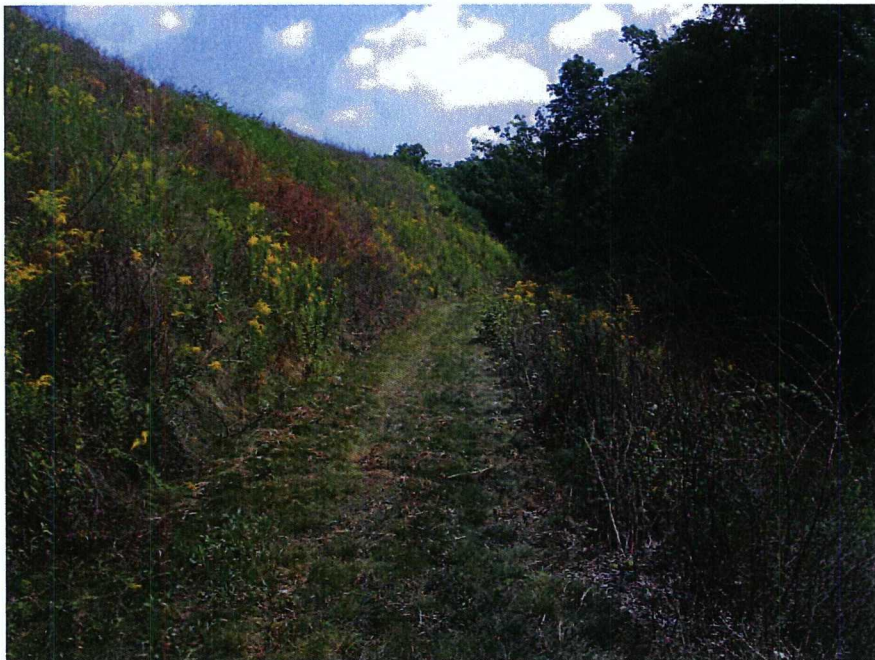
Photo 7: Path on southern end of landfill

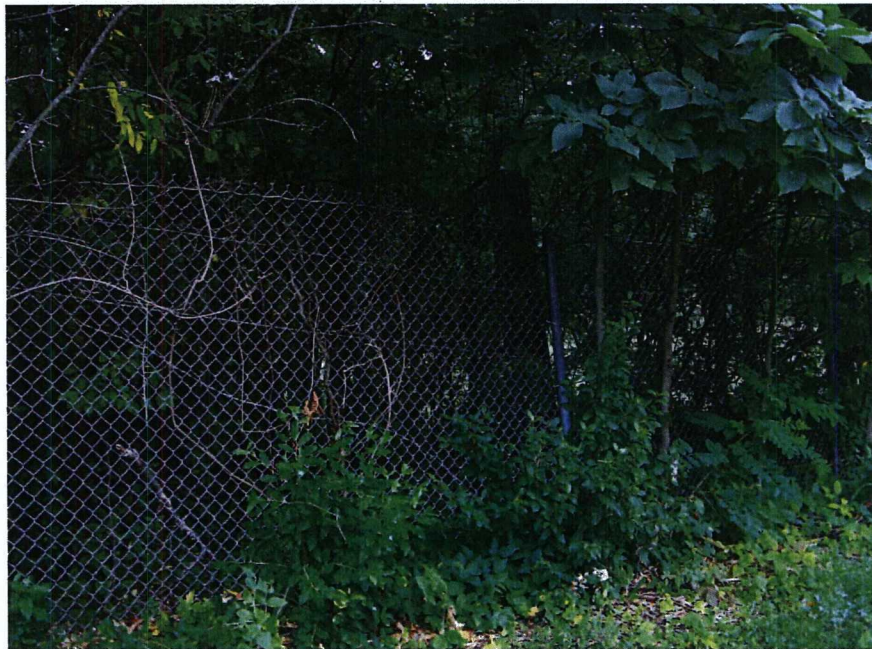
Fencing around the Site appeared to be adequate and intact. Signs were also placed on the fence around the Site. The fence to the Site is locked.

Photo 8: Fencing along southern end of landfill

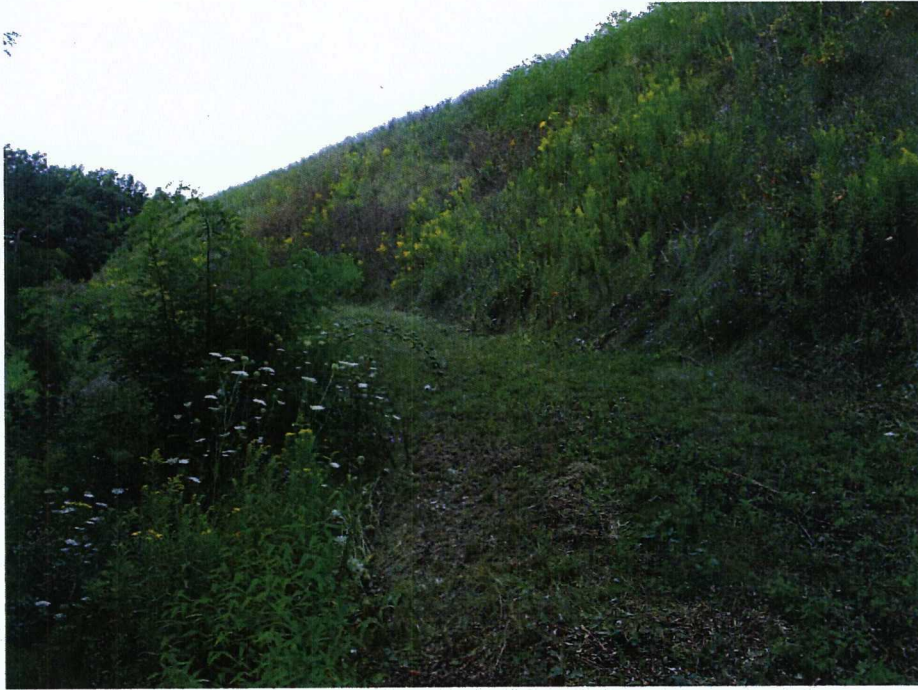
Photo 9: Path along the southern end of the landfill

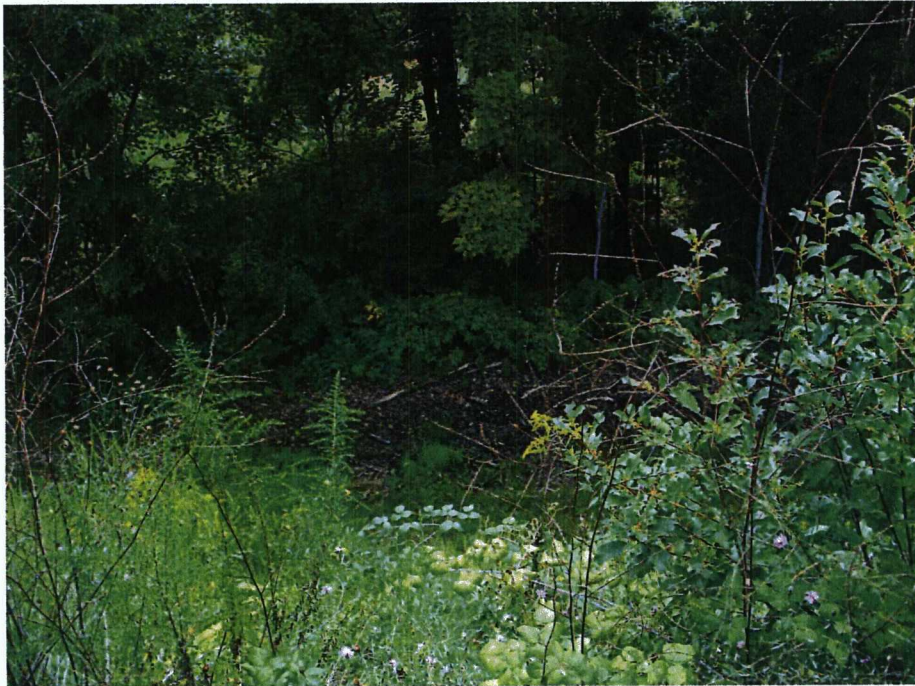
Photo 10: Fencing and slope along southern end of landfill

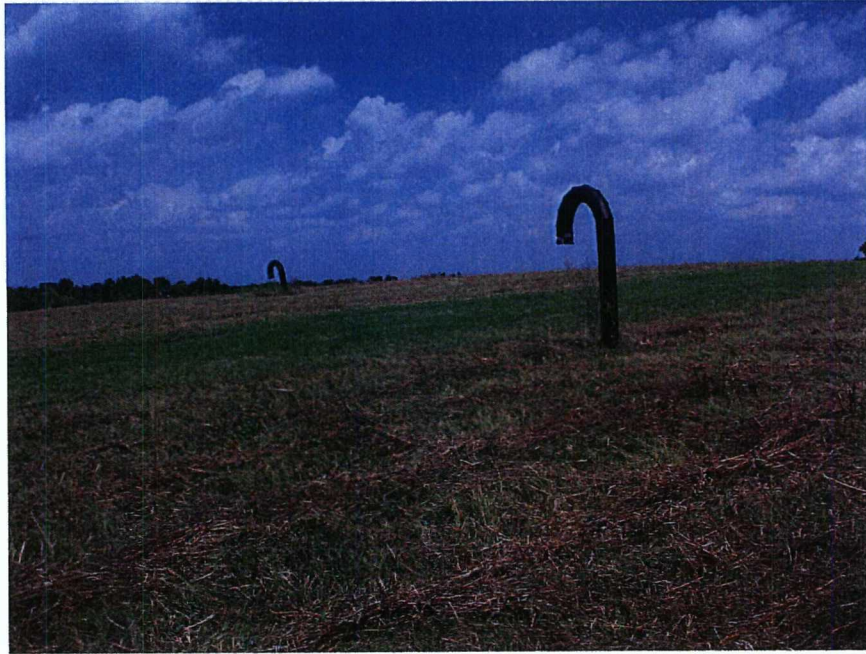
The Site has passive gas vents. The gas vents were sampled initially, but after review of the low emissions from the vents, the gas vents were no longer required to be sampled.

Photo 11: Passive gas vents on top of landfill

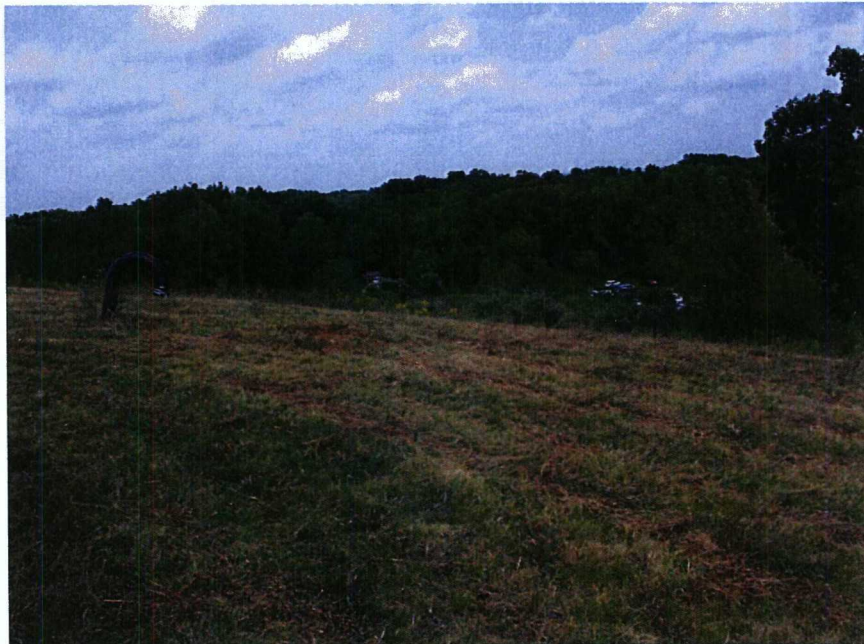
Photo 12: Passive gas vent on top of landfill

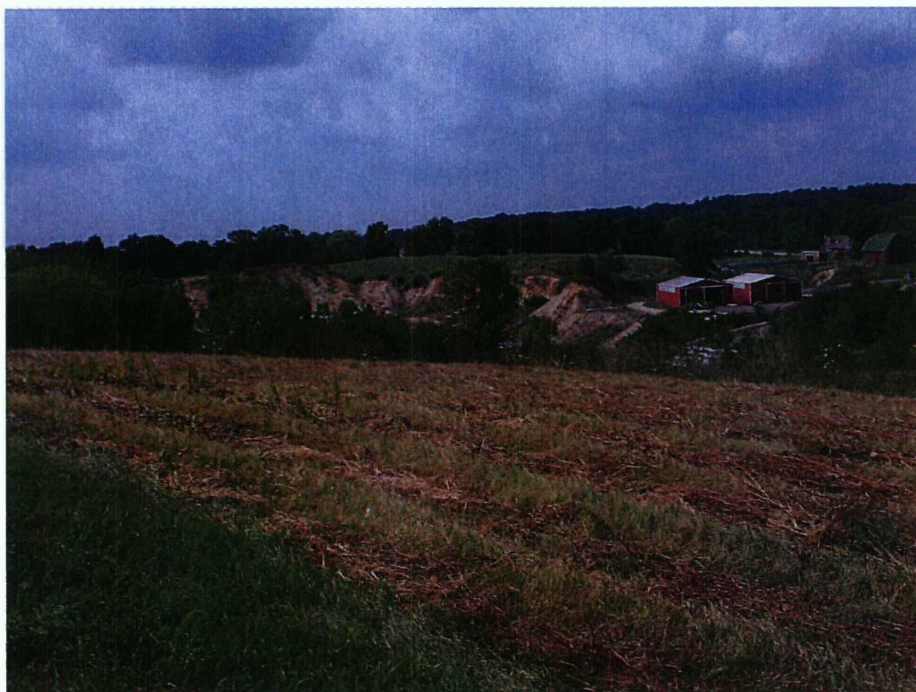
Photo 11: Top of landfill overlooking NPL Deleted Spiegelberg Superfund site

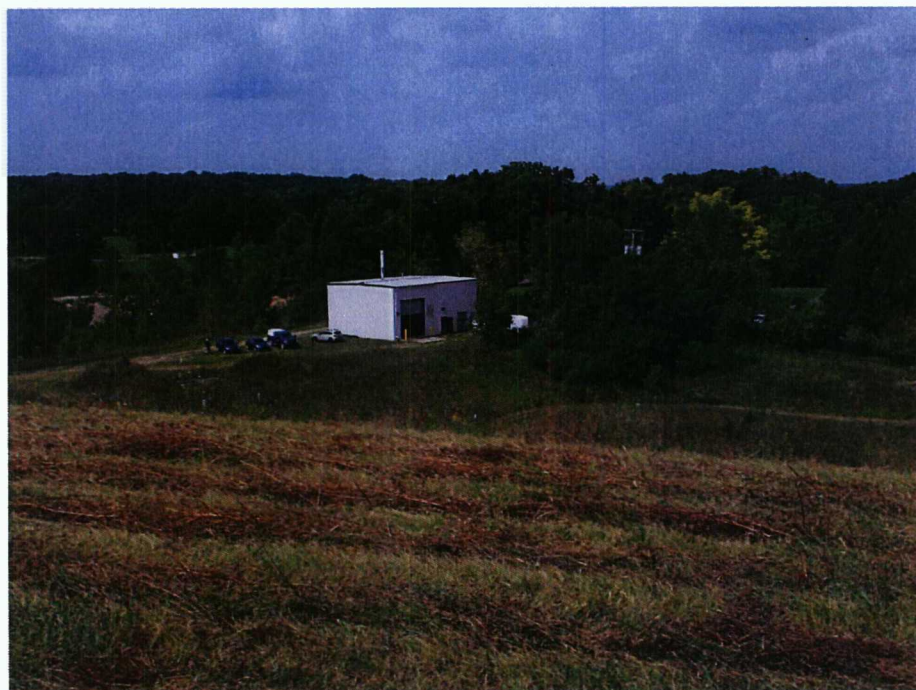
The groundwater is being treated with an Ozone/Oxygen Sparging System. The ozone/oxygen sparging system consists of an air compressor, oxygen concentrator, ozone generator (ozone generated by super high voltage), a distribution panel and more distribution valves in front of the treatment plant. The system is in good condition. The sampling ports are properly marked and functional and the equipment was properly identified. The electrical enclosures and panels appeared to be in good condition. The treatment building also appeared to be in good condition.

Photo 12: Rasmussen's Dump Ozone Sparging Building

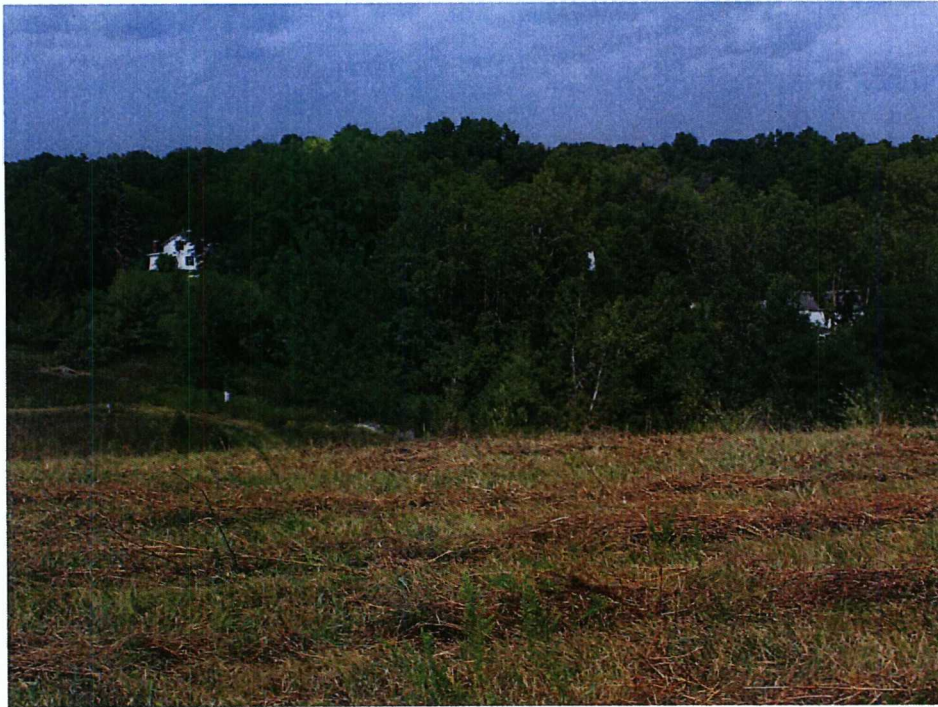
Photo 13: Top of landfill overlooking Rasmussen property

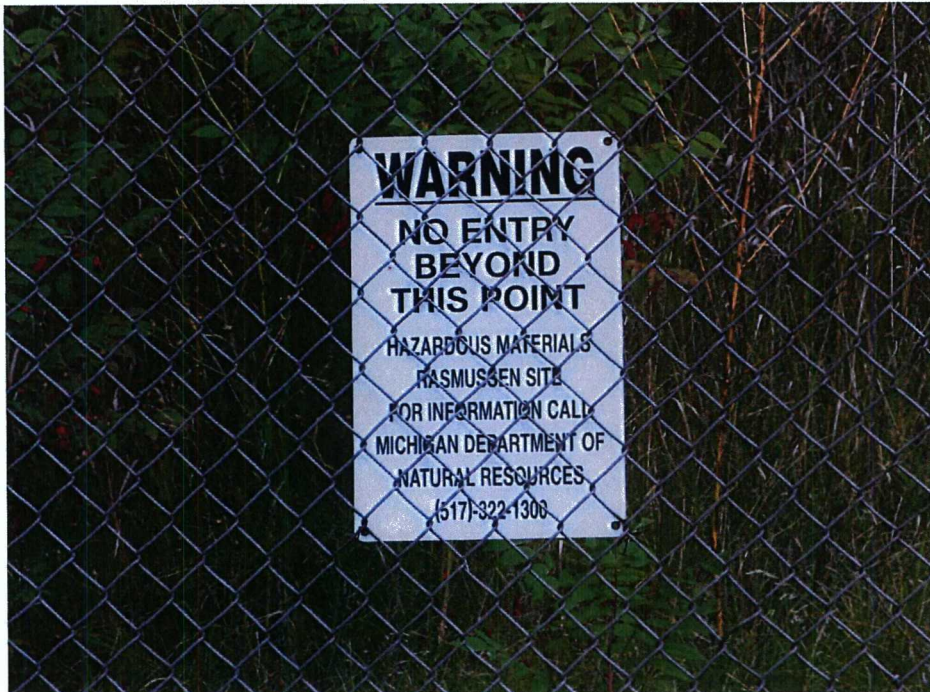
Photo 14: Warning sign posted on fence

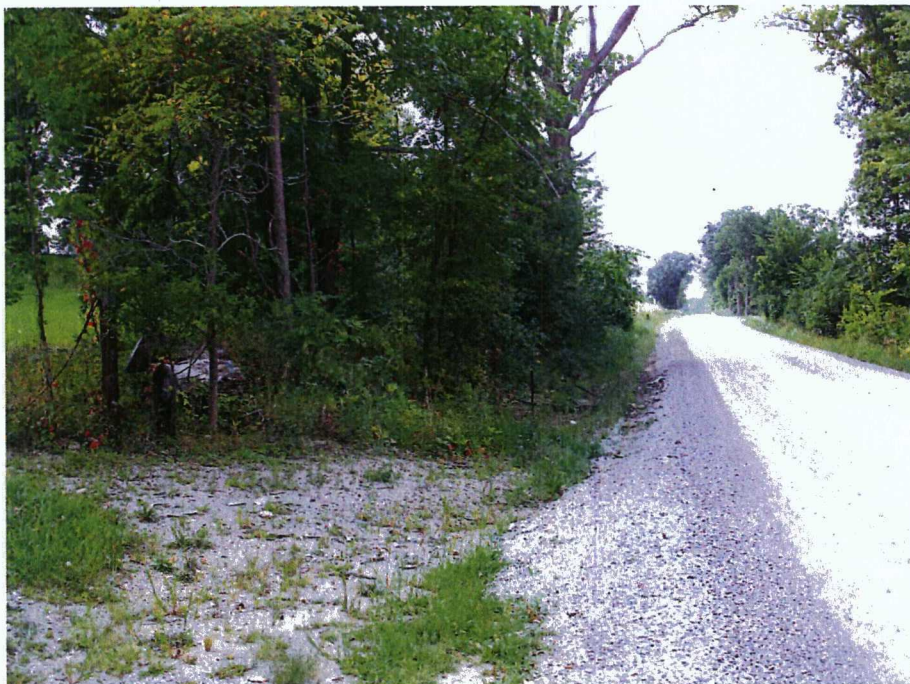
Photo 15: South side of Spicer Road facing west

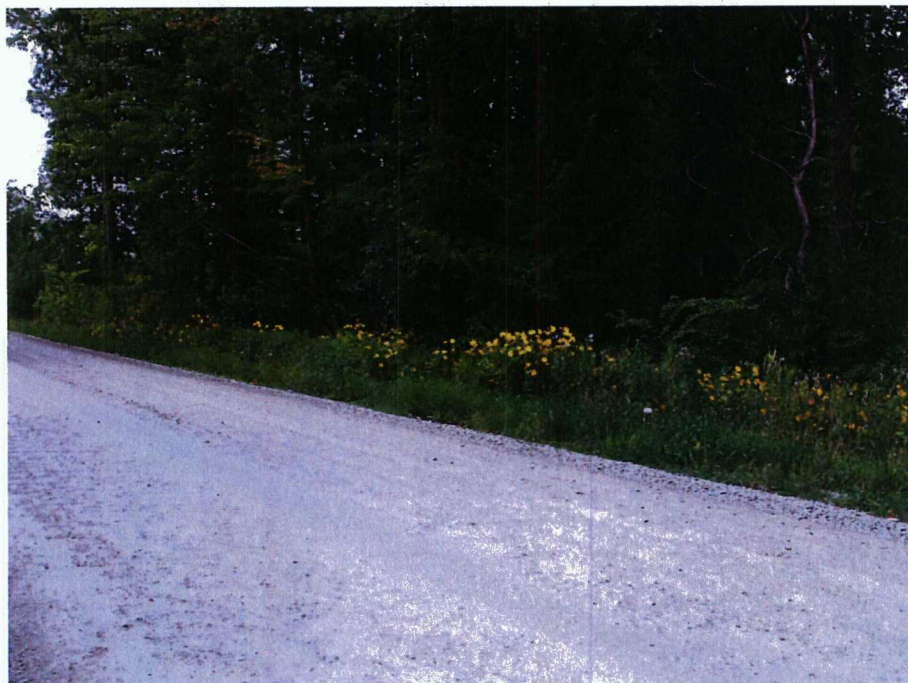
Photo 16: South side of Spicer Road facing west

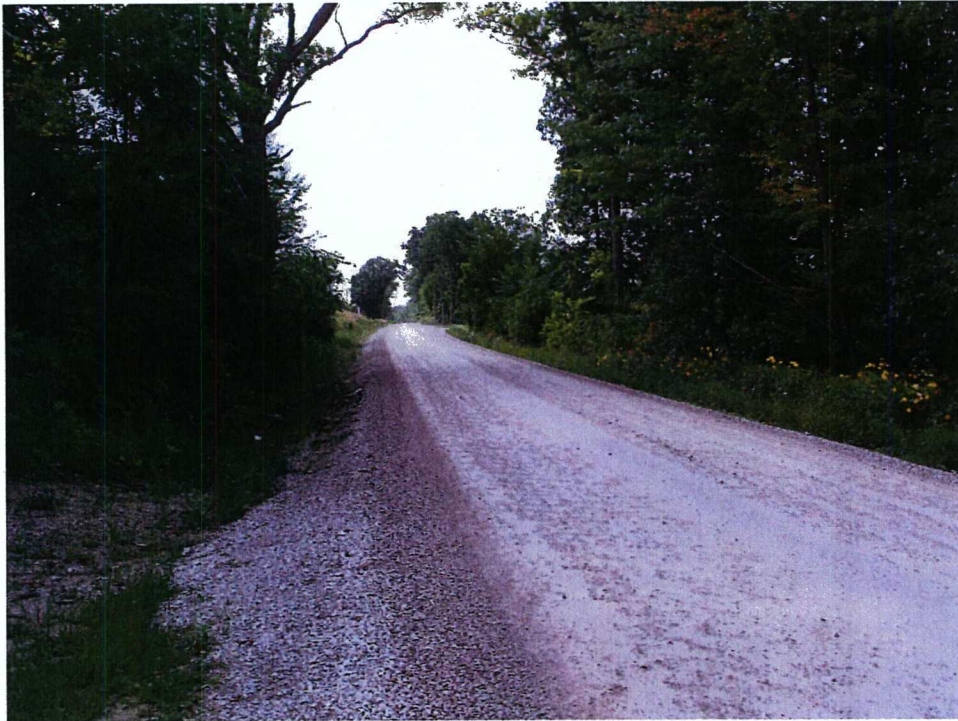
Photo 17: Spicer Road facing west

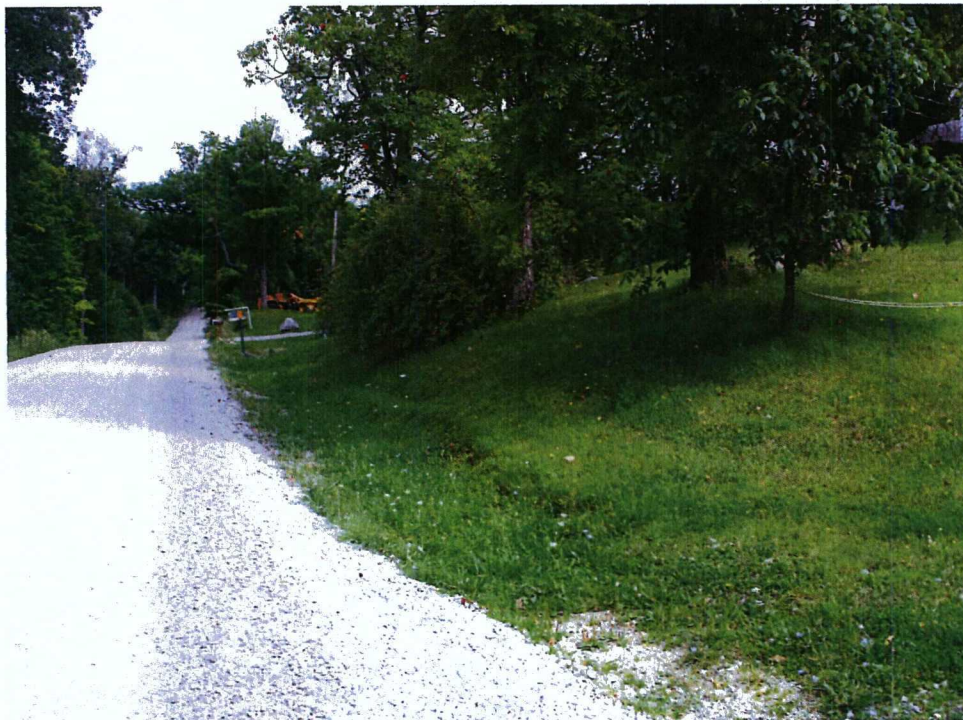
Photo 18: South side of Spicer Road facing east

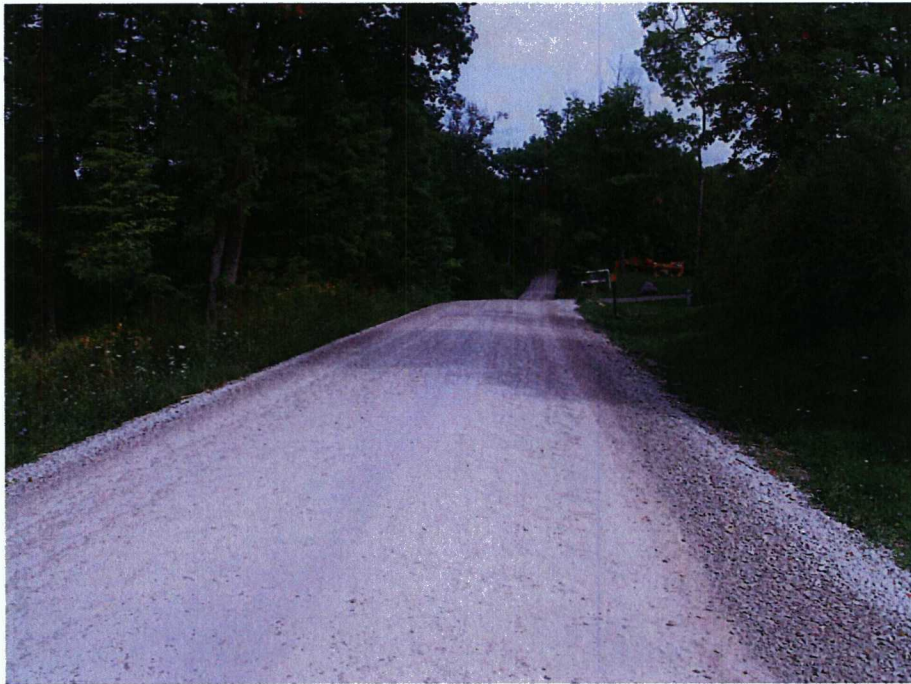
Photo 19: Spicer Road facing east

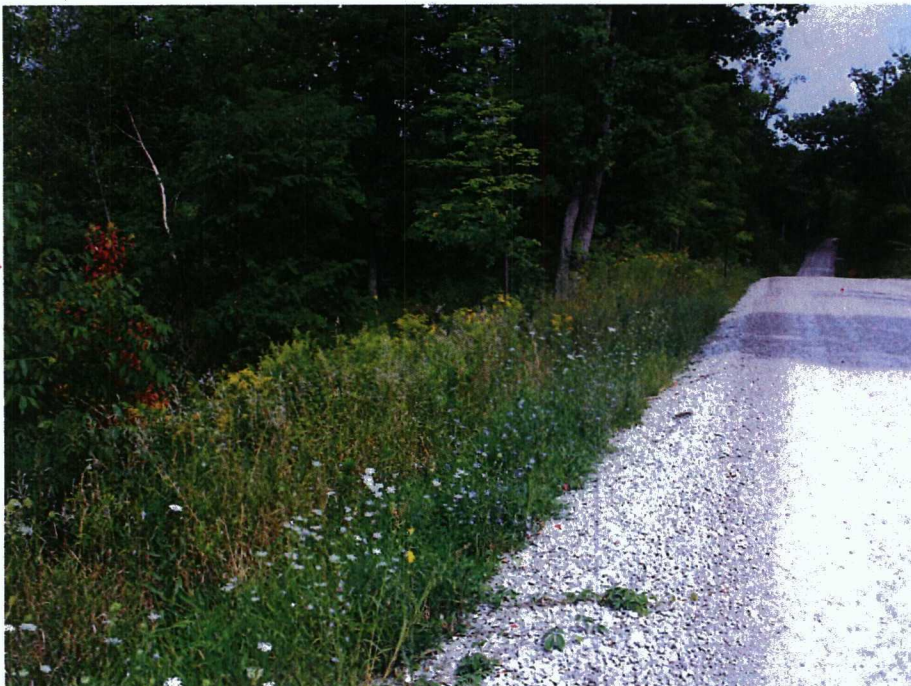
Photo 20: North side of Spicer Road facing east
